NEW YORK STATE DEPT OF ENVIRONMENTAL CONSERVATION ALBANY F/6 13/13
NATIONAL DAM SAFETY PROGRAM. WARNER DAM, CHAUTAUGUA LAKE OUTLET--ETC(U)
SEP 80 B L THOMSEN, G L WOOD

REPORT DOCUMENTATION PAGE		READ INSTRUCTIONS BEFORE COMPLETING FORM
1. REPORT NUMBER	2. GOVT ACCESSION NO.	3. RECIPIENT'S CATALOG NUMBER
	AD-A090 937	
4. TITLE (and Subtitle) Phase I Inspection Report Warrer Dam-Chautauqua Lake Outlet Allegheny River Basin, Chautauqua County, New York Inventory No. 750		5. TYPE OF REPORT & PERIOD COVERED Phase I Inspection Report National Dam Safety Program

PHASE I INSPECTION REPORT
NATIONAL DAM SAFETY PROGRAM
WARNER DAM
I.D. NO. N.Y. 750
ALLEGHENY RIVER BASIN
CHAUTAUQUA COUNTY, NEW YORK

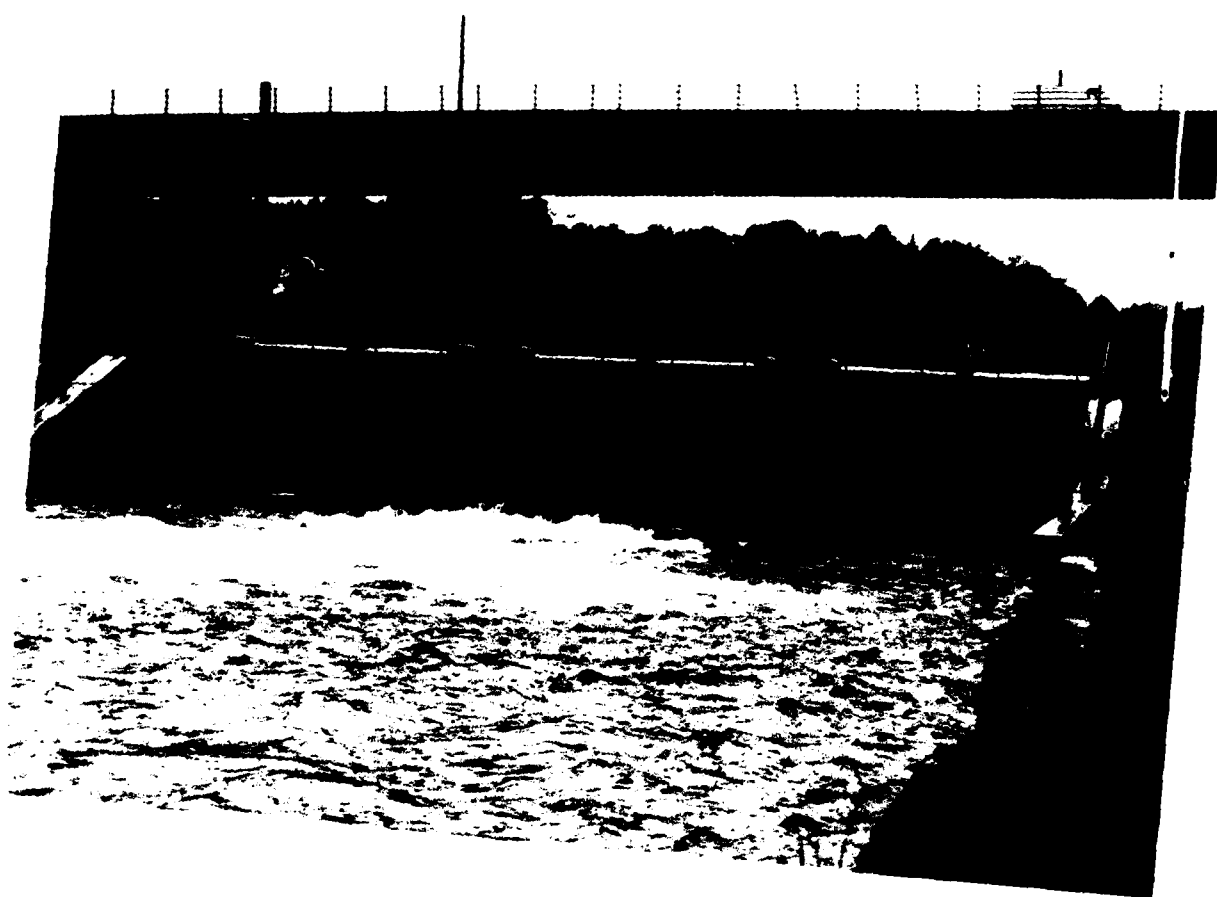
View of Downstream
face of Dam.
